CALIFORNIA CULVERT REHAB

HIGH-STRENGTH POLYMER CONCRETE LINER PROVIDES COST-SAVING SOLUTION FOR REHABILITATING CORRODED CULVERT

BY JOE ROYER AND FIL BORRONI

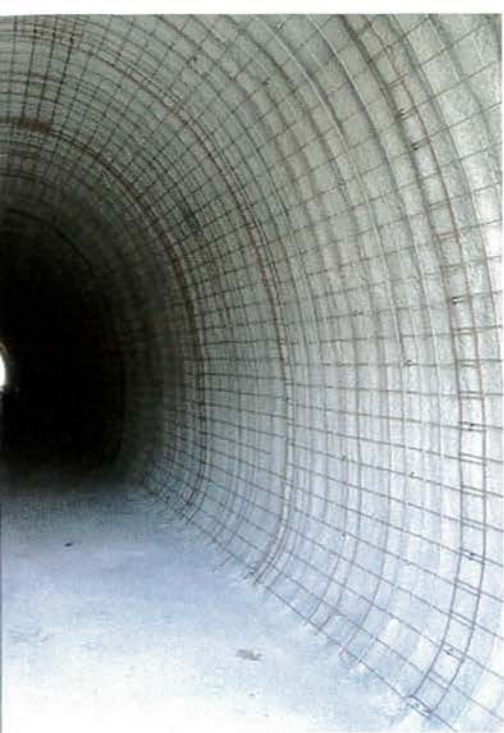
FOR THIS PROJECT, INLAND PIPE REHABILITATION DETERMINED THE BEST METHOD OF APPLICATION WAS TO SPRAY-APPLY THE PRIMARY COATING, THEN FOLLOW UP WITH TROWELING TO CREATE A SMOOTH FINISH.

The application process inside the culvert was simple and easy for the installation team. EcoCast can be applied with a precision-controlled spray application apparatus, or troweled on, depending on the type of structure. For this project, IPR determined the best method of application was to spray-apply the primary coating, then follow up with troweling to create a smooth finish. One of the major advantages of EcoCast is that a crew can layer the material, allowing the application of evenly applied product up to the required thickness, regardless of unforeseen stops or starts.
